Re: Steelcote Manufacturing Company

Enclosed is a description of corrective actions taken and a schedule for completion of other corrective actions to be taken by Steelcote Manufacturing Company in response to EPA's March 6, 1991 RCRA notice of violation.

Response of Steelcote Manufacturing Company
to March 6, 1991 RCRA Notice of Violation

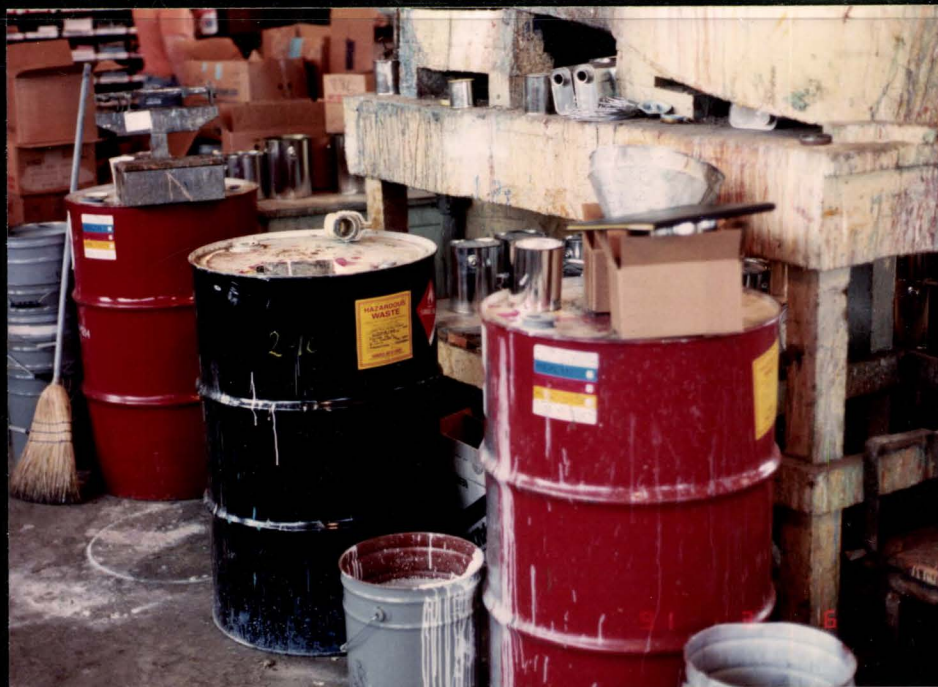
Both hazardous waste storage areas are diked with concrete bricks which are lined with a chemical resistant coating to contain any spill that might occur. Telephones (located in each part of the plant, including approximately three feet away from the outside storage area, near the still area, and 15 feet from the basement storage area) are available to call fire and emergency numbers. Fire extinguishers (located throughout the plant, including approximately three feet away from the outside storage area, near the still area, and 15 feet from the basement storage area) are available if needed. Both hazardous waste storage areas are covered by sprinklers.

By March 29, 1991, Steelcote will purchase and place near the two hazardous waste storage areas and the still area an appropriate amount of absorbent material that can be used to control spills.

A fire hydrant is currently located outside within 20 feet of the outside storage area, which would supply an adequate volume of water. In addition, both hazardous waste storage areas have a water sprinkler system installed above them. Steelcote will have the sprinkler system extended over the still area as soon as possible, but by no later than April 30, 1991.
